## Site Inspection Report for Former Nansemond Ordnance Depot, Suffolk, VA

DERP FUDS Project No. **C03VA004502**

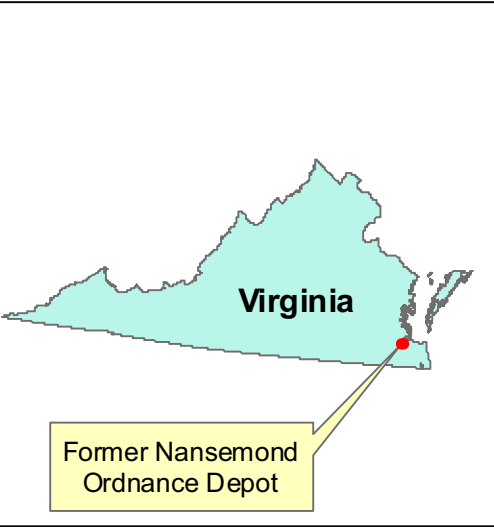
**Figure 3-3. Background Sample Locations**

**3.3.2.5 Background Samples:** As agreed upon during the TPP meeting and presented in the Final SS-WP (Alion 2010), background soil sample results were compared to background data obtained from previous sampling events that occurred within the FUDS, specifically the analytical results from the Final Background Sampling Program that was issued in September 2004 (USACE 2004). Background sediment and surface water analytical results were not included in previous studies; therefore, two co-located sediment and surface water samples were collected during this SI and analyzed for metals only (Figure 3-3). The background sediment and surface water samples collected during the 2010 SI field event were located upstream of the AOC 2 sediment and surface water samples collected from Streeter Creek. No sites of interest related to the former uses of FNOD have been identified in the vicinity of the background sample locations (USACE 2008).

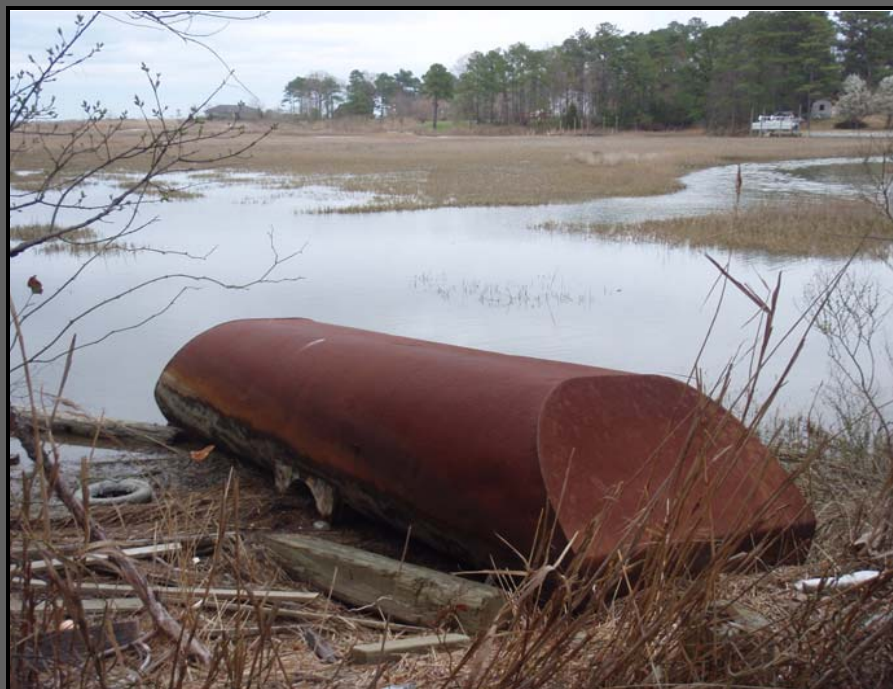
Site:	Former Nansmond Ordnance Depot
Photographer:	Cheryl Gannon
Location of Photograph:	Area Of Concern (AOC) 2
GPS Coordinates:	N <u>4084351.39</u> E <u>373560.31</u>
(UTM Zone 18N)	
Direction of Photo:	East
Comments:	Wetlands and metal cultural debris observed within AOC 2.
Photograph No.:	<u>E.1</u>
Date:	<u>3/22/2010</u>
Time:	<u>16:30</u>

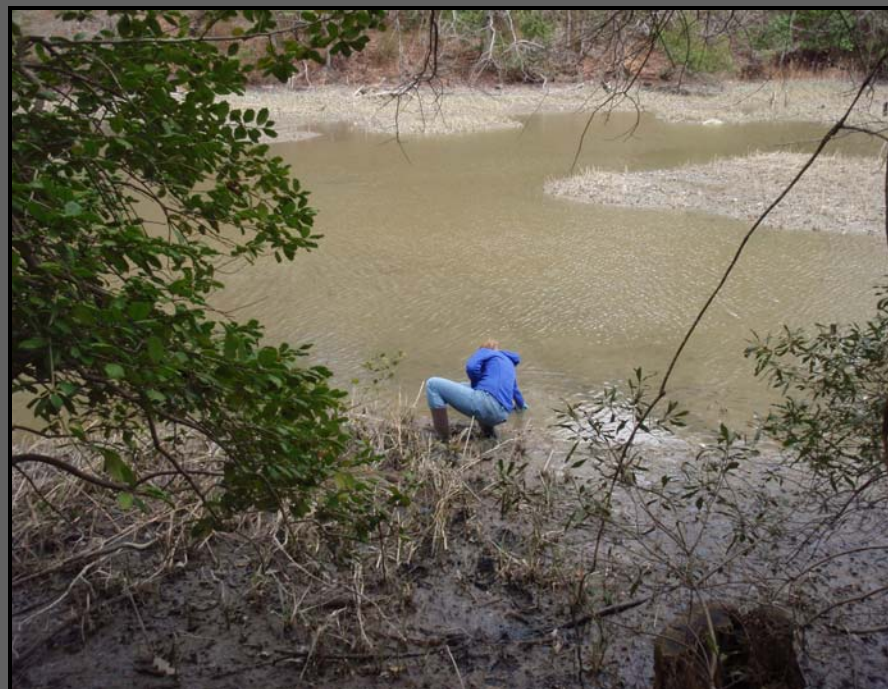
Site:	Former Nansmond Ordnance Depot
Photographer:	Cheryl Gannon
Location of Photograph:	AOC 2
GPS Coordinates:	N <u>4084328.01</u> E <u>373476.81</u>
(UTM Zone 18N)	
Direction of Photo:	East
Comments:	Collection of sample FNOD-AOC2-SW-00-01 within AOC 2.
Photograph No.:	<u>E.2</u>
Date:	<u>3/23/2010</u>
Time:	<u>13:00</u>

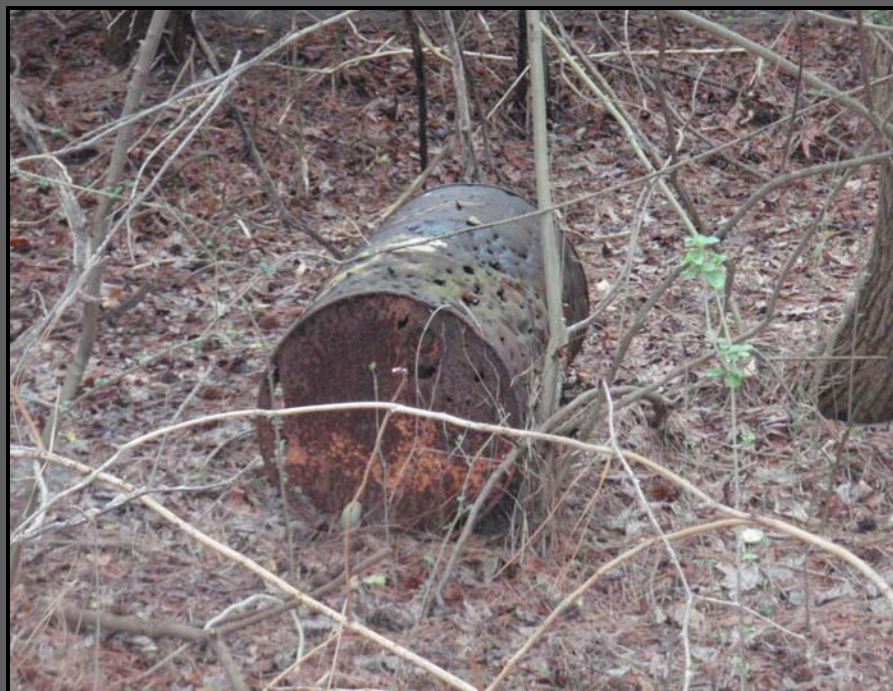
Site:	Former Nansmond Ordnance Depot
Photographer:	Cheryl Gannon
Location of Photograph:	AOC 8
GPS Coordinates:	N <u>4084273.292</u> E <u>373320.53</u>
(UTM Zone 18N)	
Direction of Photo:	Ground
Comments:	Metal cultural debris observed within AOC 8.
Photograph No.:	<u>E.3</u>
Date:	<u>3/23/2010</u>
Time:	<u>14:35</u>

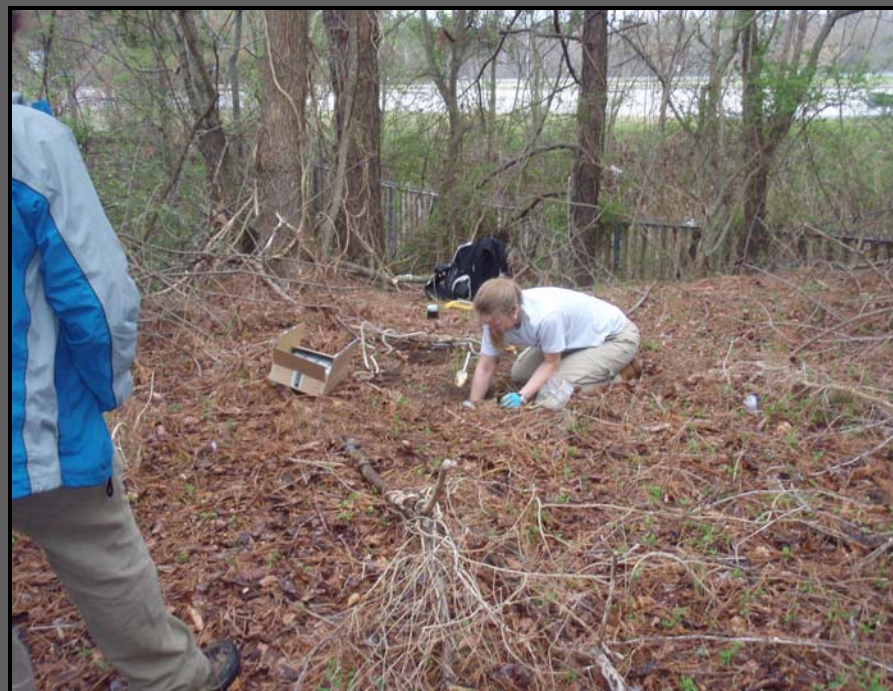
Site:	Former Nansmond Ordnance Depot
Photographer:	Cheryl Gannon
Location of Photograph:	AOC 8
GPS Coordinates:	N <u>4084284.16</u> E <u>373115.51</u>
(UTM Zone 18N)	
Direction of Photo:	West
Comments:	Collection of co-located samples FNOD-AOC8-SS-01-01 and FNOD-AOC8-SB-02-01 near fence in AOC 8.
Photograph No.:	<u>E.4</u>
Date:	<u>3/22/2010</u>
Time:	<u>12:54</u>

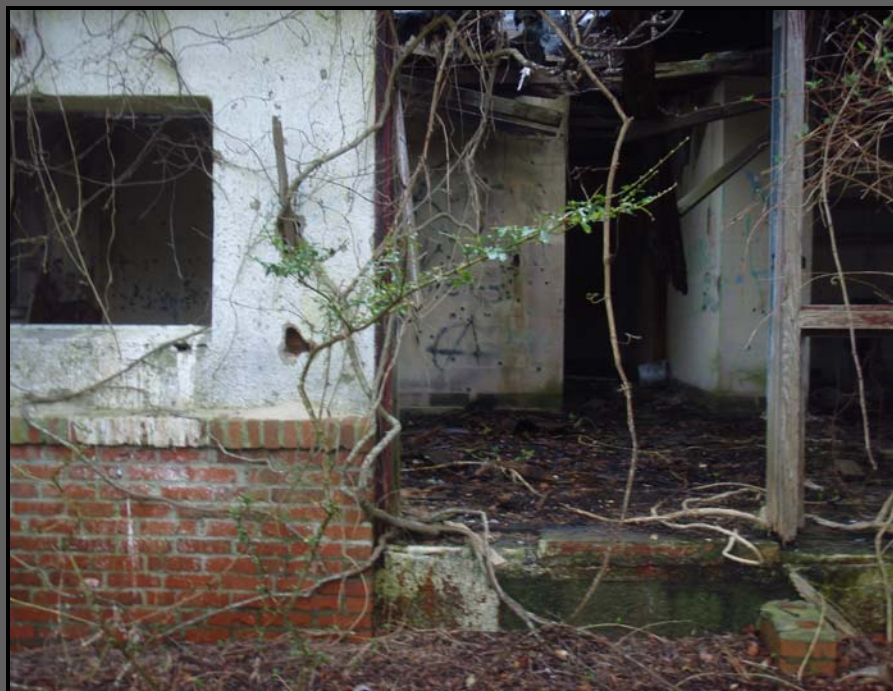
Photograph No.: E.5 Date: 3/22/10 Time: 13:29

Comments: Existing structure at AOC 9.

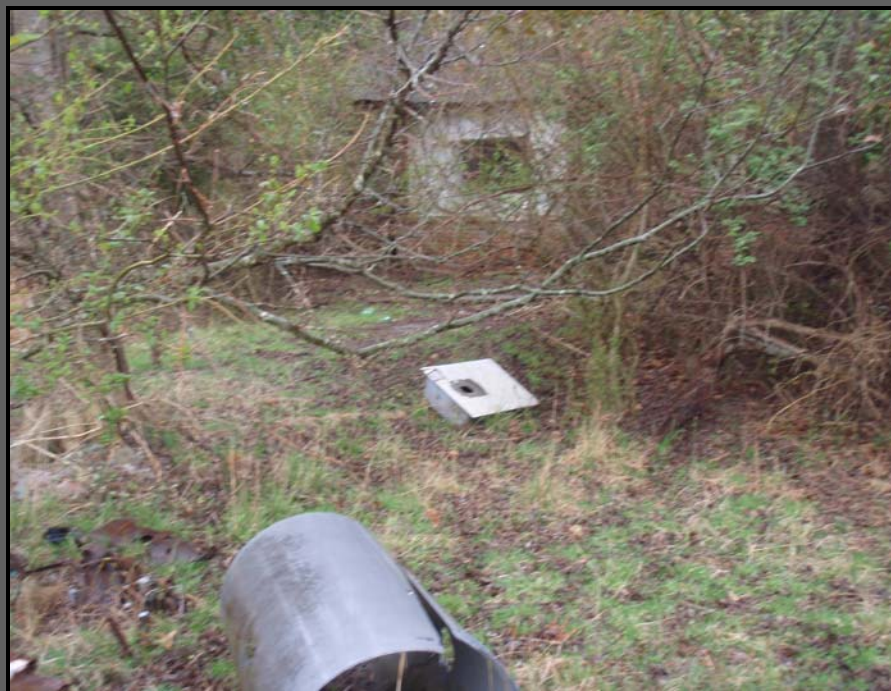
Photograph No.: E.6 Date: 3/22/10 Time: 13:28

Comments: Cultural debris observed during field activities within AOC 9.

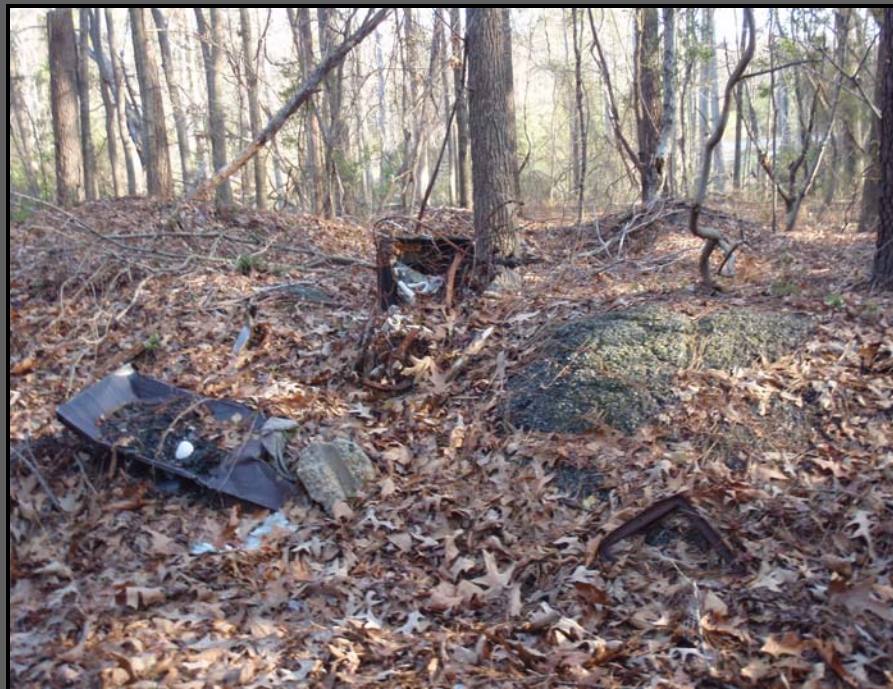
Site:	Former Nansemond Ordnance Depot
Photographer:	Cheryl Gannon
Location of Photograph:	AOC 10
GPS Coordinates:	N <u>4084565.69</u> E <u>372550.60</u>
(UTM Zone 18N)	
Direction of Photo:	Toward the ground
Comments:	Current condition and cultural debris observed during field activities at AOC 10.
Photograph No.:	<u>E.7</u>
Date:	<u>3/24/10</u>
Time:	<u>08:41</u>

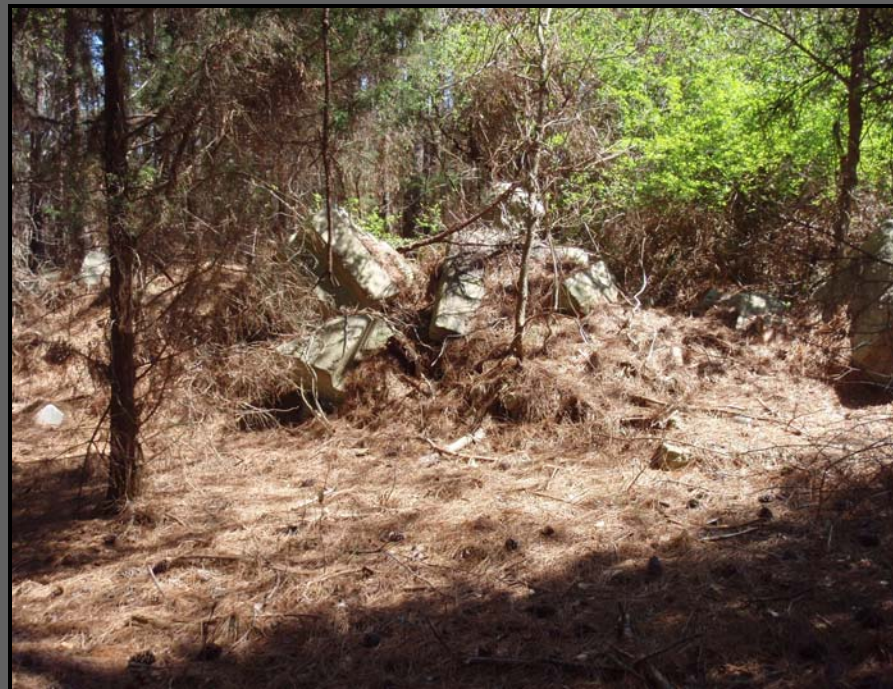
Site:	Former Nansemond Ordnance Depot
Photographer:	Cheryl Gannon
Location of Photograph:	AOC 11
GPS Coordinates:	N <u>4084628.35</u> E <u>372845.42</u>
(UTM Zone 18N)	
Direction of Photo:	Toward the ground
Comments:	Current condition and cultural debris observed during field activities at AOC 11.
Photograph No.:	<u>E.8</u>
Date:	<u>3/24/10</u>
Time:	<u>13:03</u>

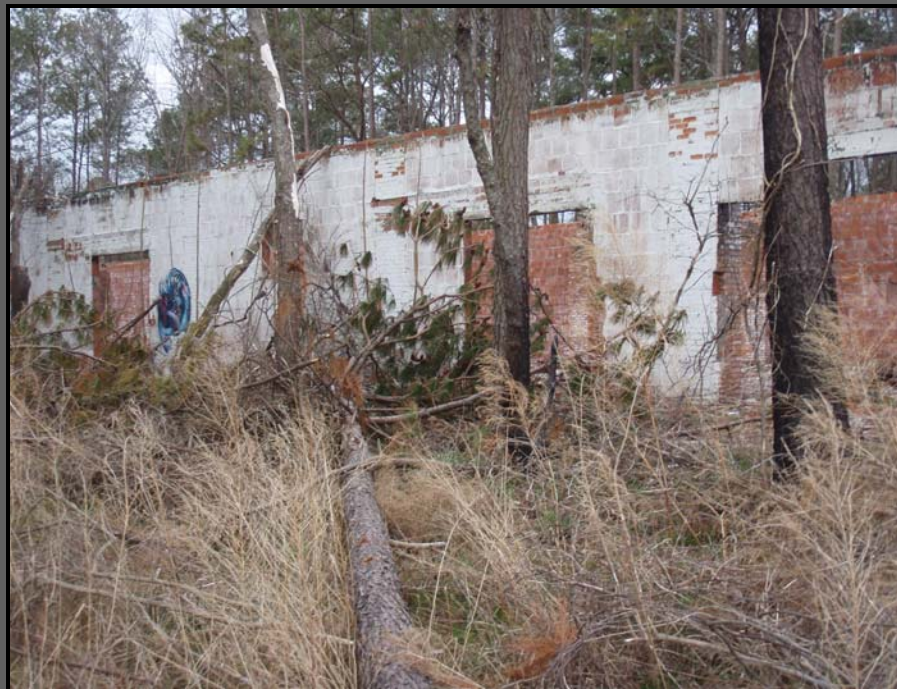
Site:	Former Nansmond Ordnance Depot
Photographer:	Cheryl Gannon
Location of Photograph:	AOC 12
GPS Coordinates:	N <u>4084996.03</u> E <u>372953.78</u>
(UTM Zone 18N)	
Direction of Photo:	West
Comments:	Existing structure at AOC 12.
Photograph No.:	<u>E.9</u>
Date:	<u>3/22/10</u>
Time:	<u>07:43</u>

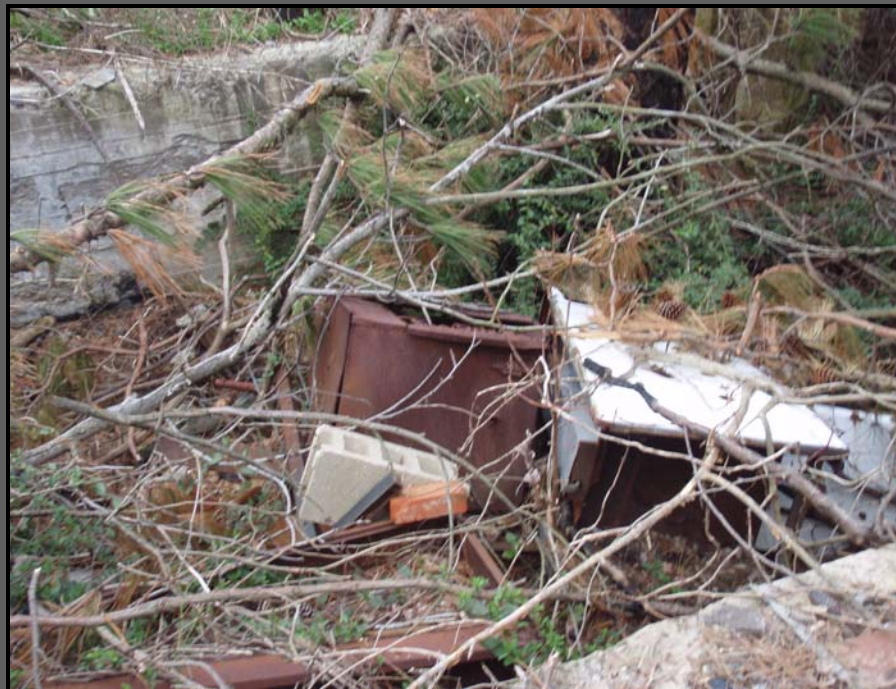
Site:	Former Nansmond Ordnance Depot
Photographer:	Cheryl Gannon
Location of Photograph:	AOC 12
GPS Coordinates:	N <u>4084977.22</u> E <u>372945.01</u>
(UTM Zone 18N)	
Direction of Photo:	Toward the ground
Comments:	Cultural debris observed during field activities at AOC 12.
Photograph No.:	<u>E.10</u>
Date:	<u>3/22/10</u>
Time:	<u>07:43</u>

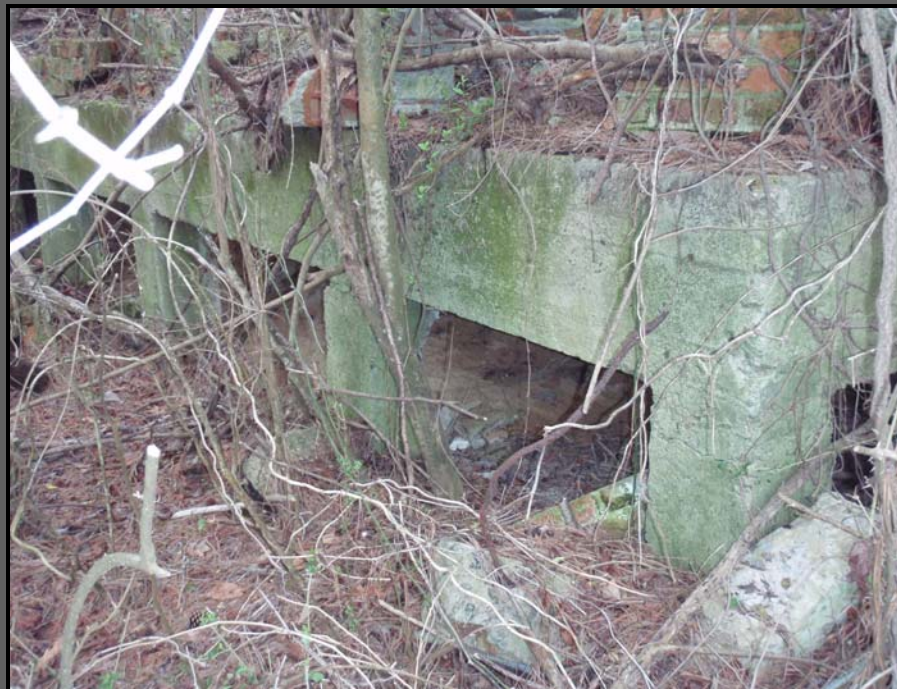
Site:	Former Nansemond Ordnance Depot
Photographer:	Cheryl Gannon
Location of Photograph:	AOC 14
GPS Coordinates:	N <u>4085010.544</u> E <u>372649.86</u>
(UTM Zone 18N)	
Direction of Photo:	Southwest
Comments:	Existing concrete platform structure at AOC 14.
Photograph No.:	<u>E.11</u>
Date:	<u>3/22/10</u>
Time:	<u>09:56</u>

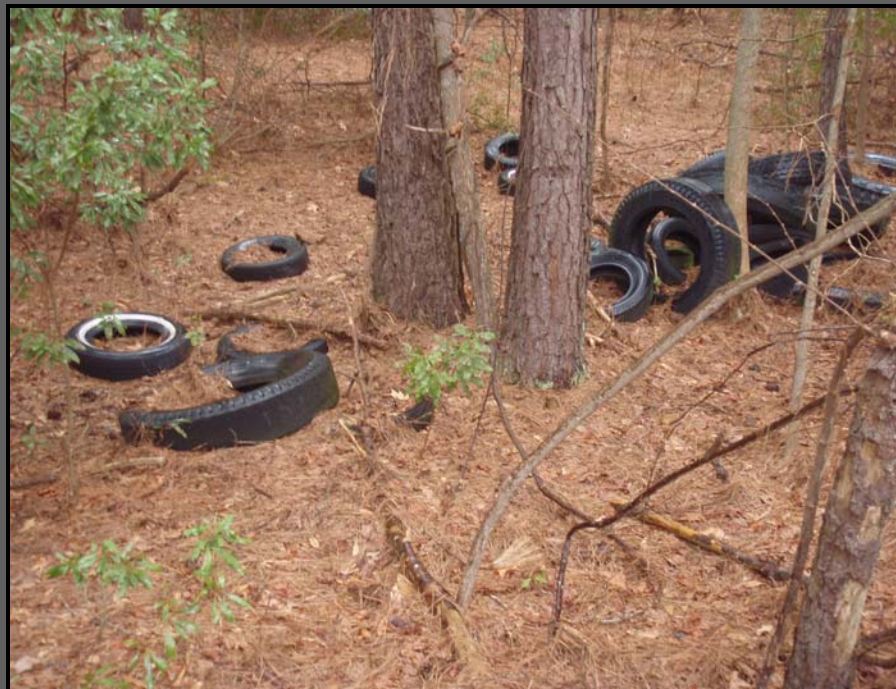
Site:	Former Nansemond Ordnance Depot
Photographer:	Cheryl Gannon
Location of Photograph:	AOC 14
GPS Coordinates:	N <u>4085026.06</u> E <u>372630.78</u>
(UTM Zone 18N)	
Direction of Photo:	Toward the ground
Comments:	Cultural debris observed during field activities at AOC 14.
Photograph No.:	<u>E.12</u>
Date:	<u>3/22/10</u>
Time:	<u>10:05</u>

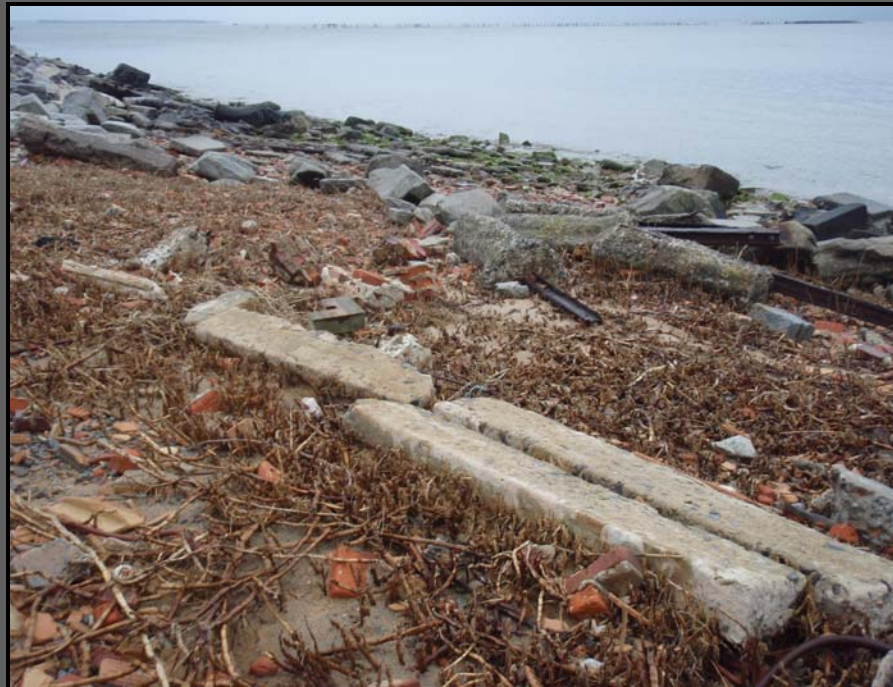
Photograph No.: E.13 Date: 3/22/10 Time: 09:27

Comments: Current site condition showing cultural debris at AOC 15 along coastline of James River.

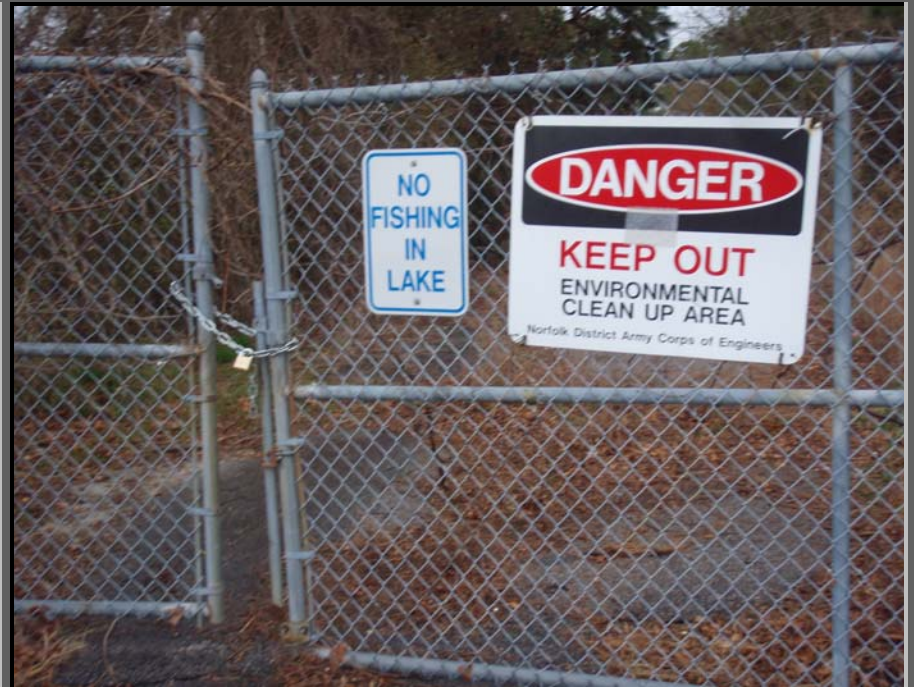
Photograph No.: E.14 Date: 3/22/10 Time: 09:34

Comments: Locked gate restricting accessing to asphalt-paved road leading to AOC 15.

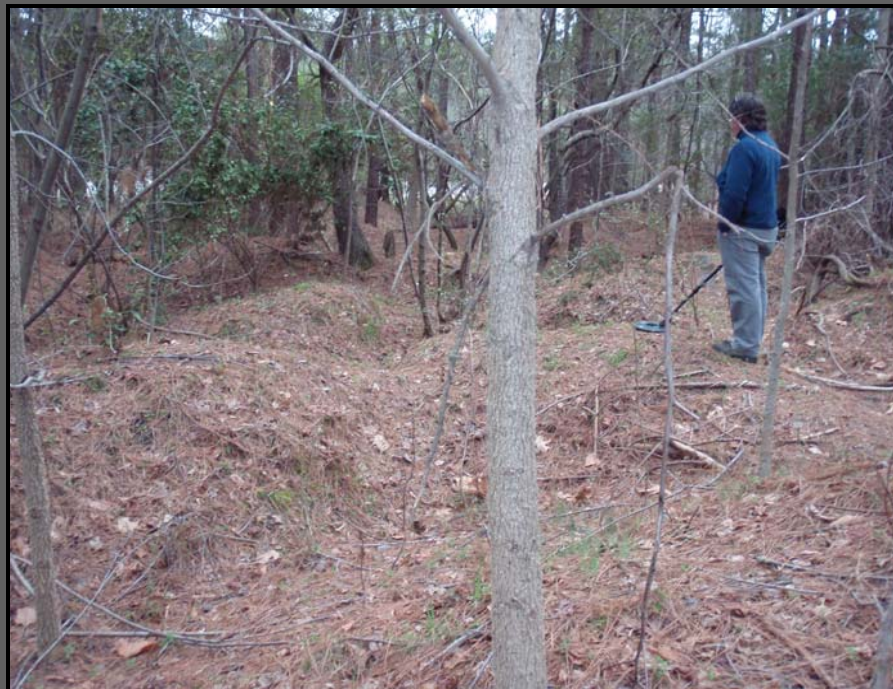
Photograph No.: E.15 Date: 3/23/10 Time: 08:34

Comments: Mounded material observed west of  
Interstate 664 (AOC 8).

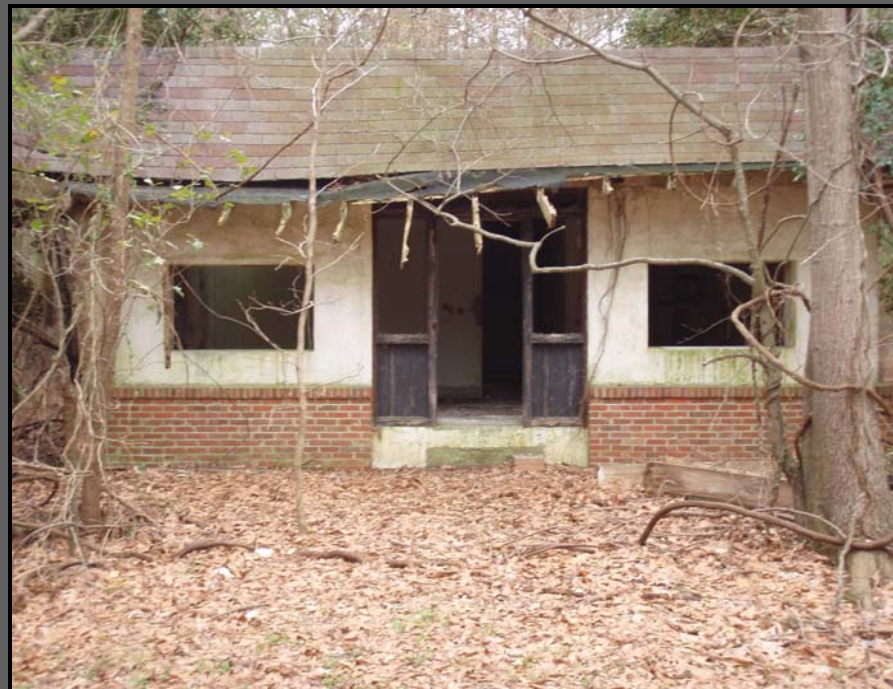
Photograph No.: E.16 Date: 3/23/10 Time: 09:47

Comments: Former magazine structure located west  
of Interstate 664 (AOC 8).
